ZWICK'S ISLAND LANDFILL
ENVIRONMENTAL INVESTIGATIONS

FINAL REPORT

OCTOBER 1991

Gartner Lee Limited

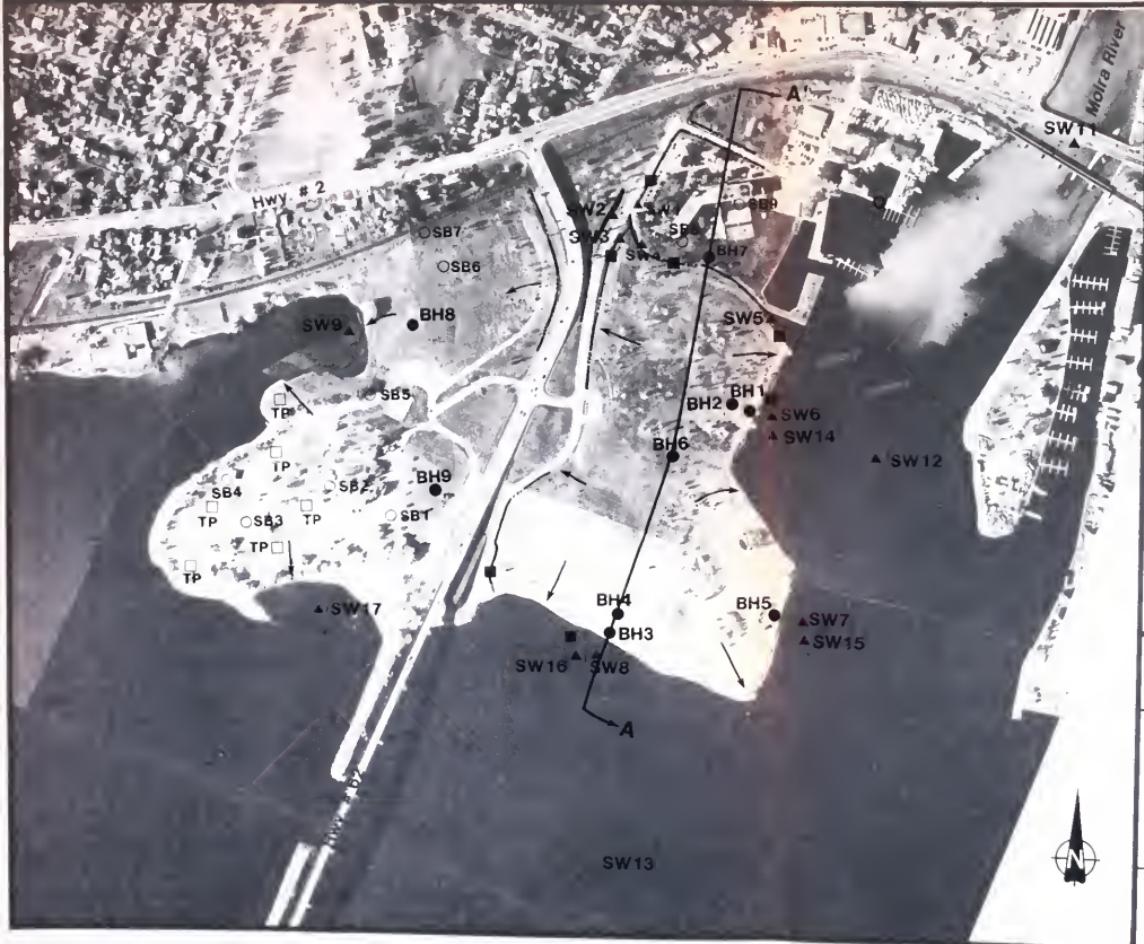
Figure
2

The hydrology of Zwick's Island is characterized by road side ditches which have intermittent flow in response to runoff events and local seepage zones. There are no surface water courses which drain into the site, and all surface water contributions to the site are in the form of precipitation. During runoff events surface water accumulates in low lying areas and infiltrates into the ground water system and/or discharges to the Bay of Quinte through drainage ditches. The largest of these ditches is located immediately west and south of the Ramada Inn. The main drainage ditches are shown on Figure 2.

The results of the combustible gas monitoring carried out in shallow hand-augered boreholes at various locations over the landfilled wastes are presented in Table C-2 in Appendix C. The gas monitoring locations are shown in Figure 2. It may be seen from the results that the highest reading observed was 6% of the lower explosive limit of methane, indicating that no significant concentrations of landfill gas were detected at any of the locations monitored.

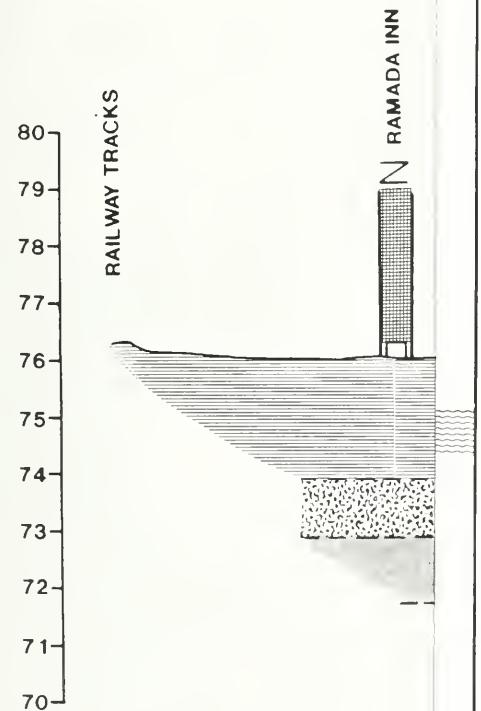
conditions encountered are presented in Appendix C. Borehole locations are shown on Figure 2. A north-south oriented cross-section through Zwick's Island is presented in Figure 4.

In two locations (BH's 1 and 3) boreholes were advanced through the earth berm which extends around the perimeter of the landfilled wastes. The berm material was similar in all aspects to the cover material encountered over the wastes in other areas. The berm was observed to vary in thickness from 2.7 to 3.1 metres, and in both cases was underlain by a sand unit. It was not possible to determine if this sand was part of the fill soils placed during berm construction, or part of the sand unit encountered in numerous boreholes advanced through the wastes.

The landfilled refuse was observed to consist of wastes such as brick, glass, rubber, timber, cloth, paper, plastic, and wire. Identifiable fragments of waste were typically contained in a brown to black soil-like or fibrous matrix. The refuse was typically soft, with 'N' values ranging from 2 to 5. The landfilled refuse was observed to vary in thickness from approximately 1.0 to 3.8 metres.

The stratum underlying the refuse consists primarily of grey to brown fine to coarse sand, with varying gravel content. The sand varied from very loose to very dense, with 'N' values ranging from 6 to over 50. In borehole 7 a stratum of clayey silt was found underlying the refuse.

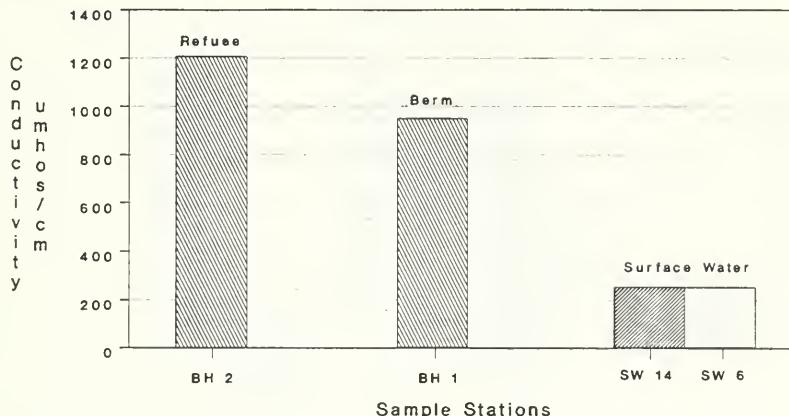
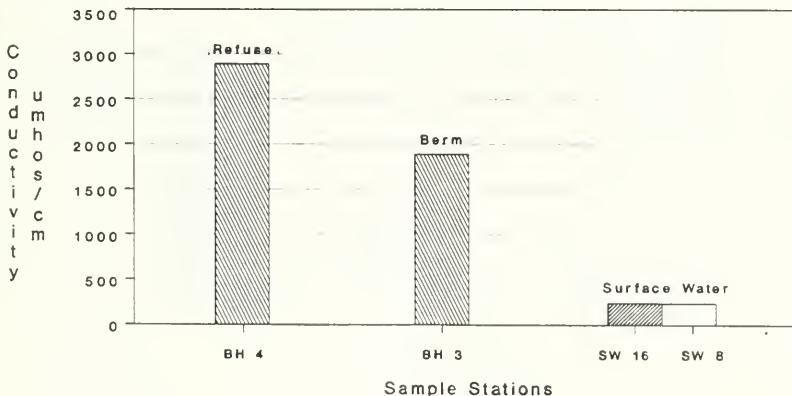
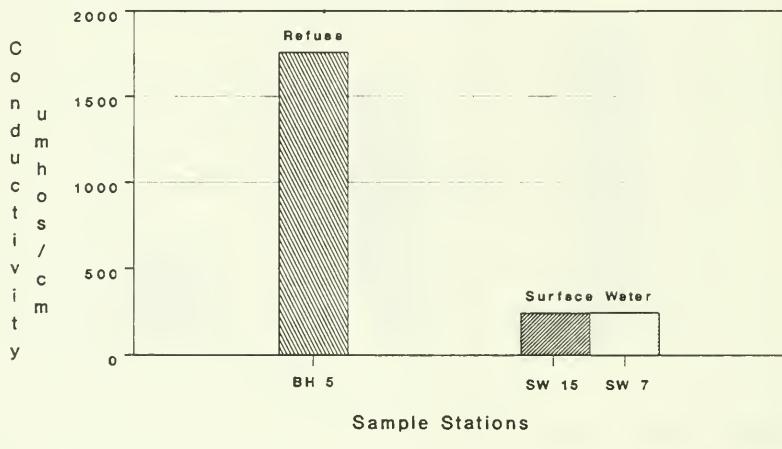
**FIGURE 7.1 COMPARISON OF CONDUCTIVITY LEVELS
ZWICKS ISLAND LANDFILL AUGUST 29-31, 1990**

Ground water conductivities varied from a low of 798 $\mu\text{S}/\text{cm}$ observed in BH 1 during the June sampling event, to an overall high of 2890 measured in BH 4 during the August sampling event. The values plotted in Figure 7.1 show that values decrease as potential for ground water dilution with bay water increases.

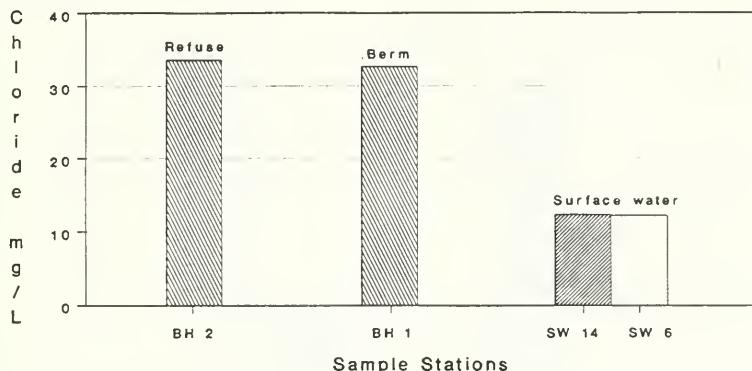
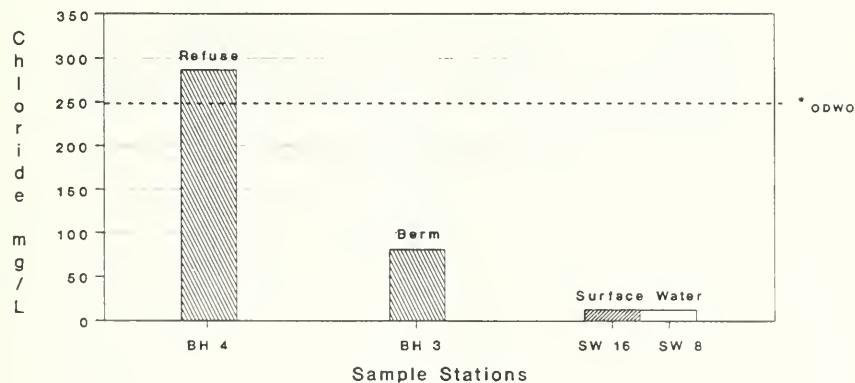
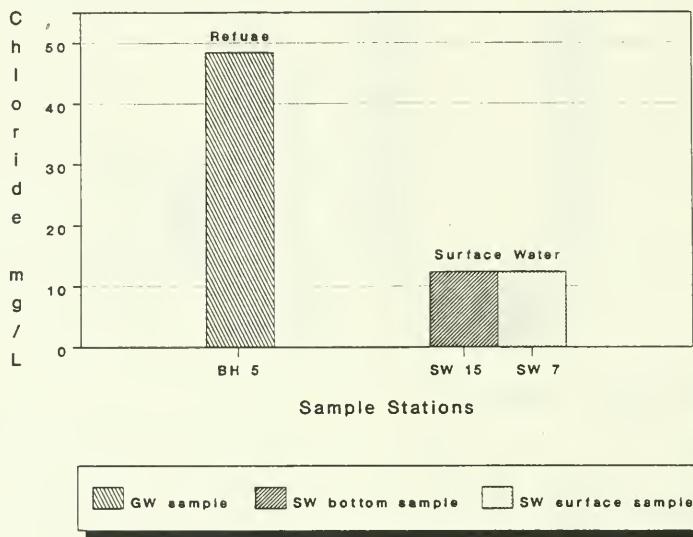
**FIGURE 7.2 : COMPARISON OF CHLORIDE CONCENTRATIONS
ZWICKS ISLAND LANDFILL AUGUST 29-31, 1990**

As with conductivity, chloride values were generally seen to be highest during the August sampling event when ground water levels were low, as well as being higher in monitors located in the island interior. The relationship of concentration as a function of increased dilution potential is seen in Figure 7.2.

* ODWO - Ontario Drinking Water Objective is 260 mg/L.

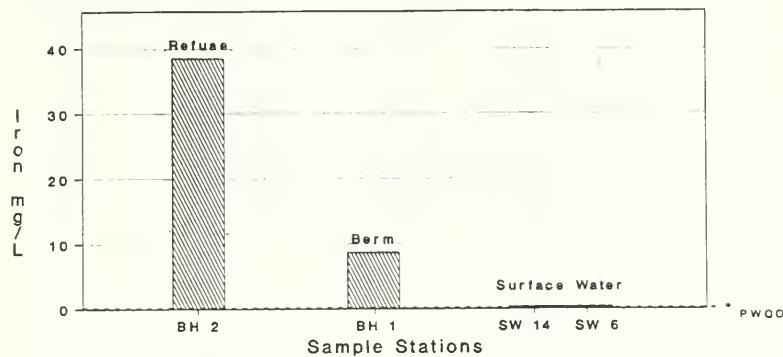
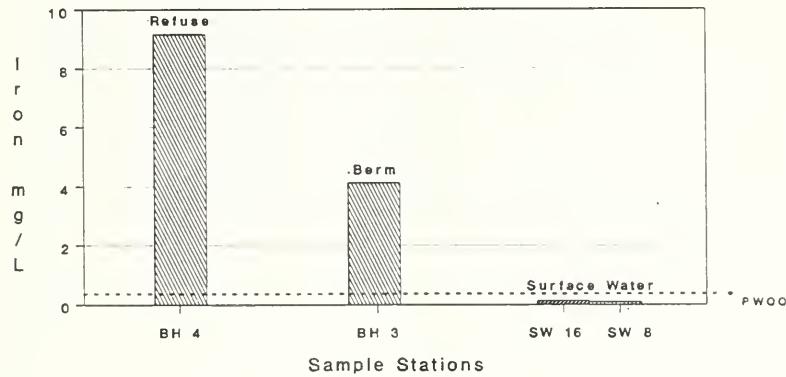
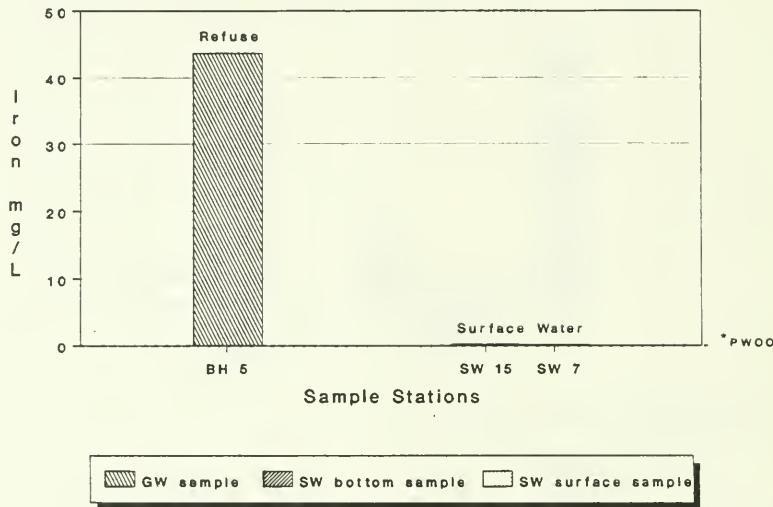
FIGURE 7.3 : COMPARISON OF IRON CONCENTRATIONS
ZWICKS ISLAND LANDFILL AUGUST 29-31, 1990

No specific trend in iron values between the wet and dry weather samplings could be discerned. As with most other parameters, concentrations decreased as distance of the sampled monitor to the Bay of Quinte decreased as shown in Figure 7.3.

* PWOO - Provincial Water Quality Objective is 0.3 mg/L.

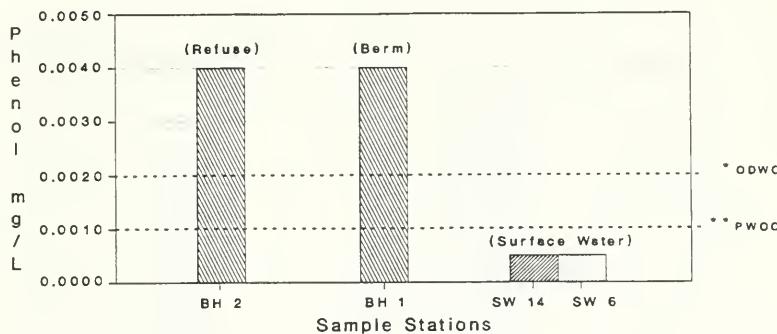
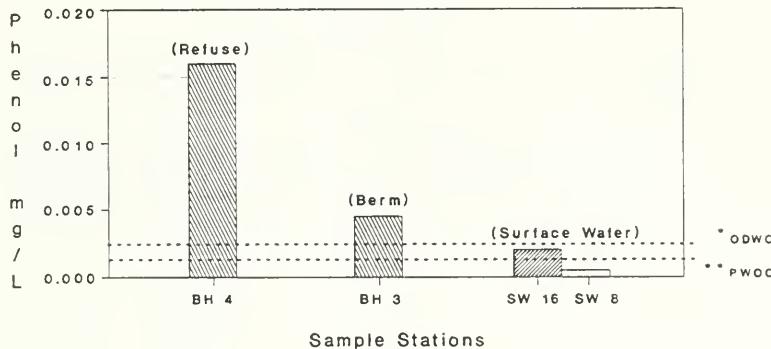
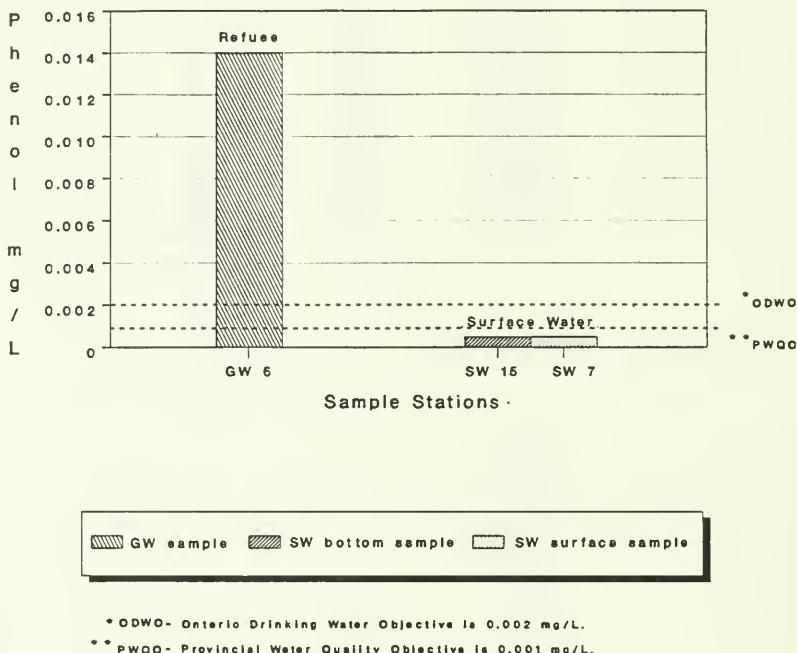
FIGURE 7.4 : COMPARISON OF PHENOL CONCENTRATIONS
ZWICKS ISLAND LANDFILL AUGUST 29-31, 1990

The relationship of phenol concentration as a function of increased dilution potential is seen in Figure 7.4.

** PWOO- Provincial Water Quality Objective is 0.001 mg/L.

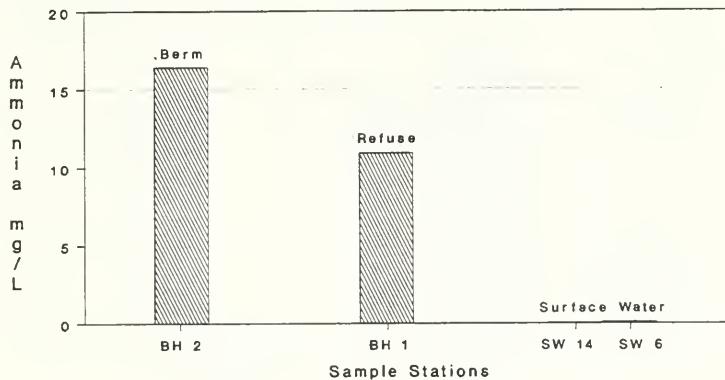
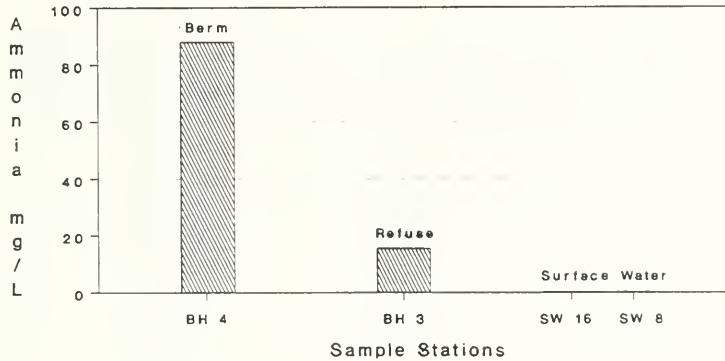
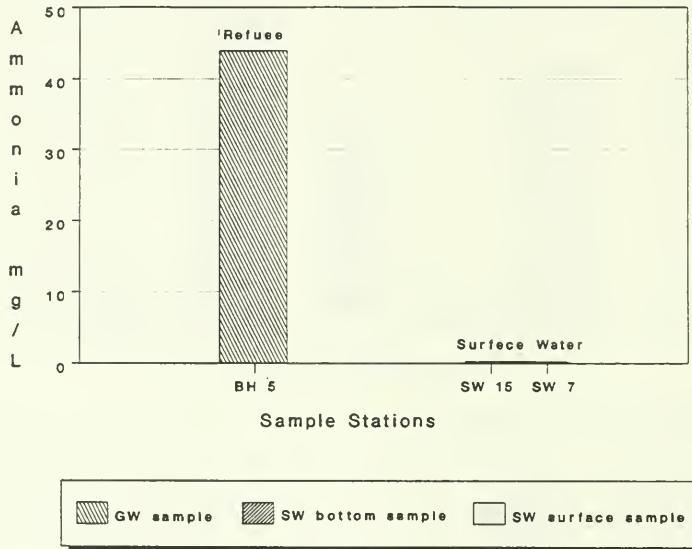
FIGURE 7.5 : COMPARISON OF AMMONIA CONCENTRATIONS
ZWICKS ISLAND LANDFILL AUGUST 29-31, 1900

As with many of the other parameters discussed, ammonia concentrations were found to decrease with decreasing distance of the sampling location to the bay. This trend is shown in Figure 7.5.

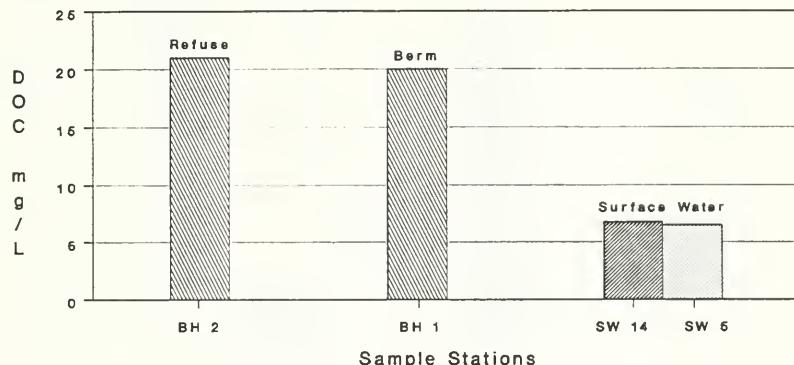
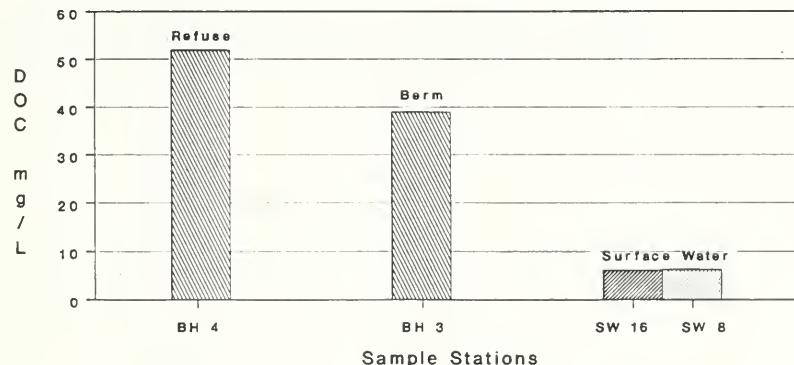
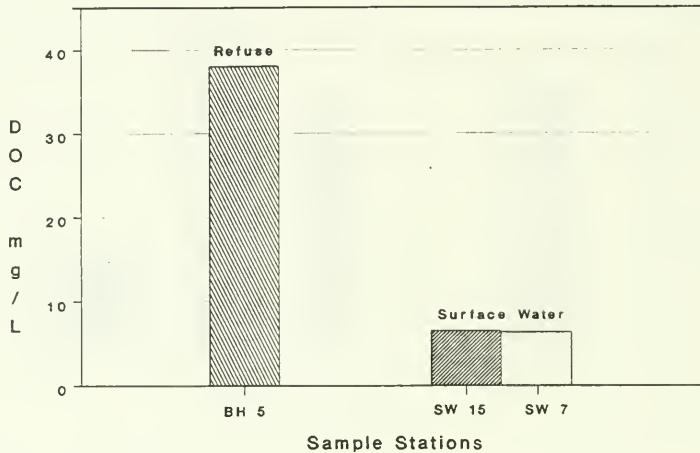
FIGURE 7.6 : COMPARISON OF DOC CONCENTRATIONS
ZWICKS ISLAND LANDFILL AUGUST 29-31, 1990

As with other parameters, both DOC and TKN values were seen to decrease with decreasing distance to the Bay of Quinte. These trends are depicted in Figures 7.6 and 7.7.

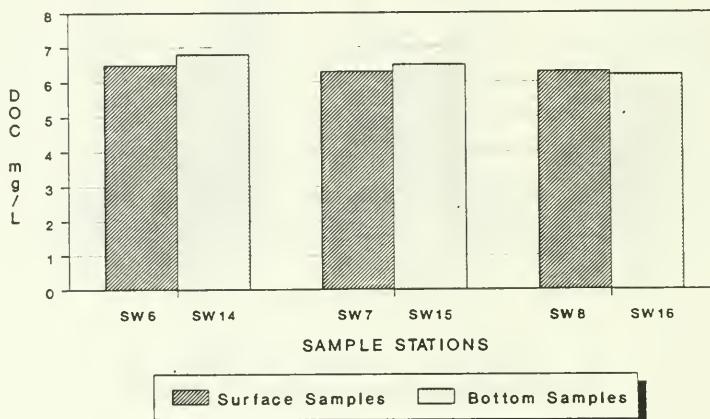
Figure 9.1: SURFACE WATER DOC CONCENTRATIONS
Comparison of Bottom and Surface Samples
Zwicks Island Landfill, August 1990

Figures 9.1 to 9.6 present a graphic representation for selected parameters of the August data from the surface and bottom samples. Generally there was little difference between the bottom and surface samples. DOC, Conductivity and Chloride showed surface and bottom concentrations approximately equal to each other. However, iron concentration were noticeably higher in bottom samples. This is likely a result of iron deposition through sedimentation processes and its release to surface water as a result of microbial activity and redox potential at the sediment water interface. Ammonia concentrations were observed to be slightly higher in the surface samples while TKN generally slightly higher in the bottom samples. The lower ammonia concentrations observed in the bottom samples could be a result of bacterial nitrification (Wetzel, 1983).

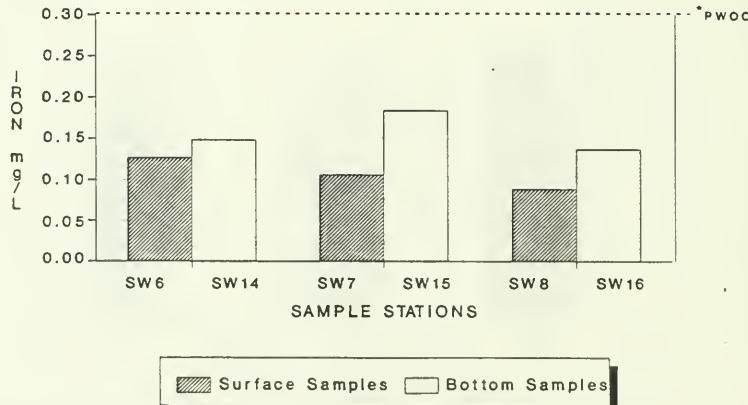
Figure 9.6: SURFACE WATER IRON CONCENTRATIONS
Comparison of Bottom and Surface Samples
Zwicks Island Landfill, August 1990

* PWOO - Provincial Water Quality Objective for iron is 0.30 mg/L.

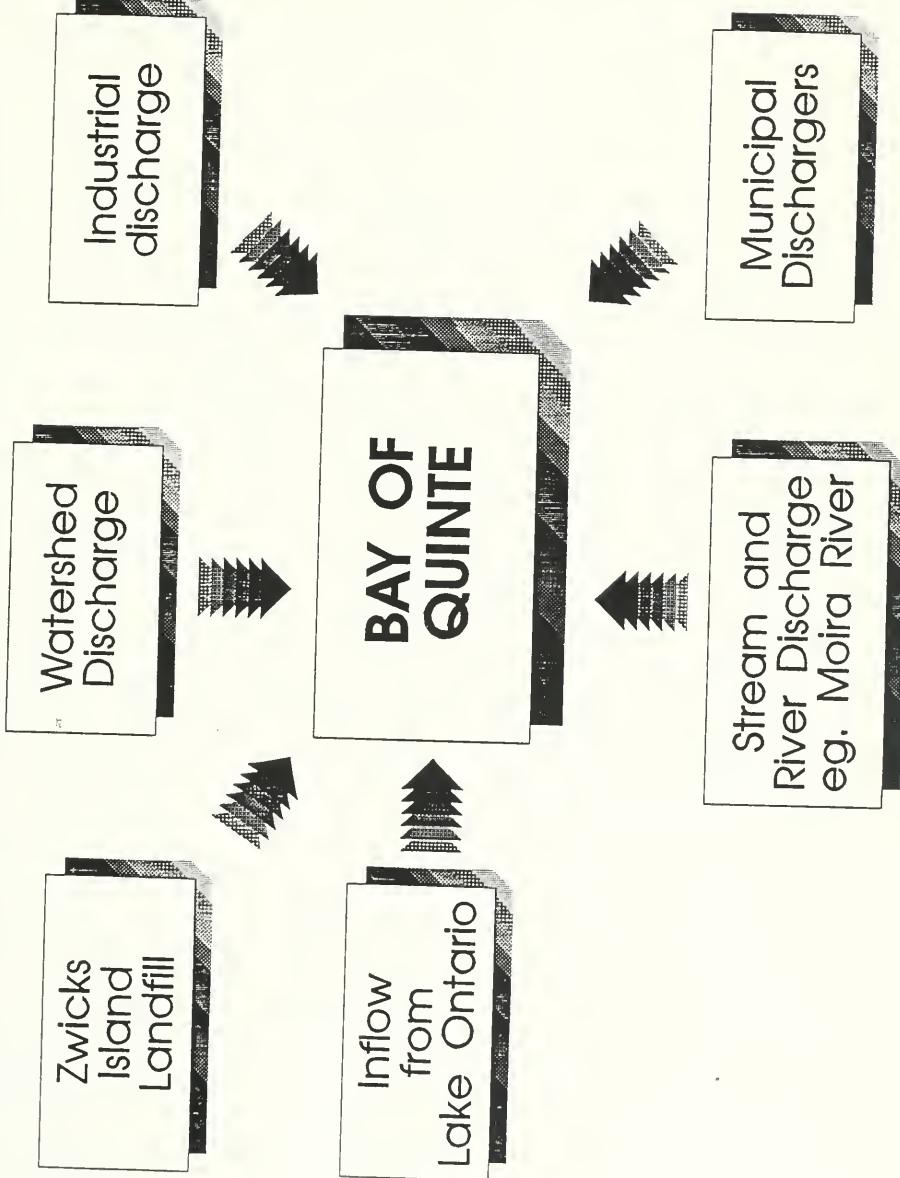
FIGURE 10

As discussed in Section 7.1.2 the flux of contaminants via ground water and from surface drainage represent the major pathways by which the Bay of Quinte is affected by Zwick's Island. These major pathways as well as other minor ones are graphically portrayed in Figure 10.

Contaminant sources to the Bay of Quinte
